## SUBJECT: Remote Condenser RCA Series

## Service Bulletin

Number:	2018-17A
Product:	Remote Condenser
Date Issued:	November 14, 2018
From:	Technical Service

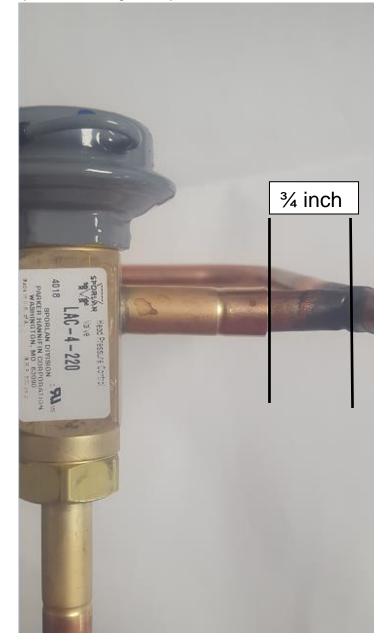
The mixing valve tubing may have been inserted too far into the T-Drill joint causing a refrigeration restriction resulting in high head pressure. If high head pressure is experienced on machine start up, the tubing can be checked by measuring the tubing distance from the mixing valve tube joint to the tubing where the T-drill joint is brazed.

A correctly assembled mixing valve should have a dimension of  $\frac{3}{4}$  of an inch from the port fitting to the upper portion of the copper tubing.

If the measurement is less than 11/16 of an inch, it will cause a restriction and should corrected by recovering the refrigerant and heating the T drill joint and reconfigure the joint to the correct dimension.
